UNITED STATES  
DEPARTMENT OF LABOR  
MINE SAFETY AND HEALTH ADMINISTRATION  
METAL AND NONMETAL MINE SAFETY AND HEALTH  
REPORT OF INVESTIGATION

Surface Nonmetal Mine  
(Sand & Gravel)

Fatal Falling Material Accident  
January 30, 2004

Khani Co. Inc.  
Khani K100  
Deming, Luna County, New Mexico  
ID No. 29-02252

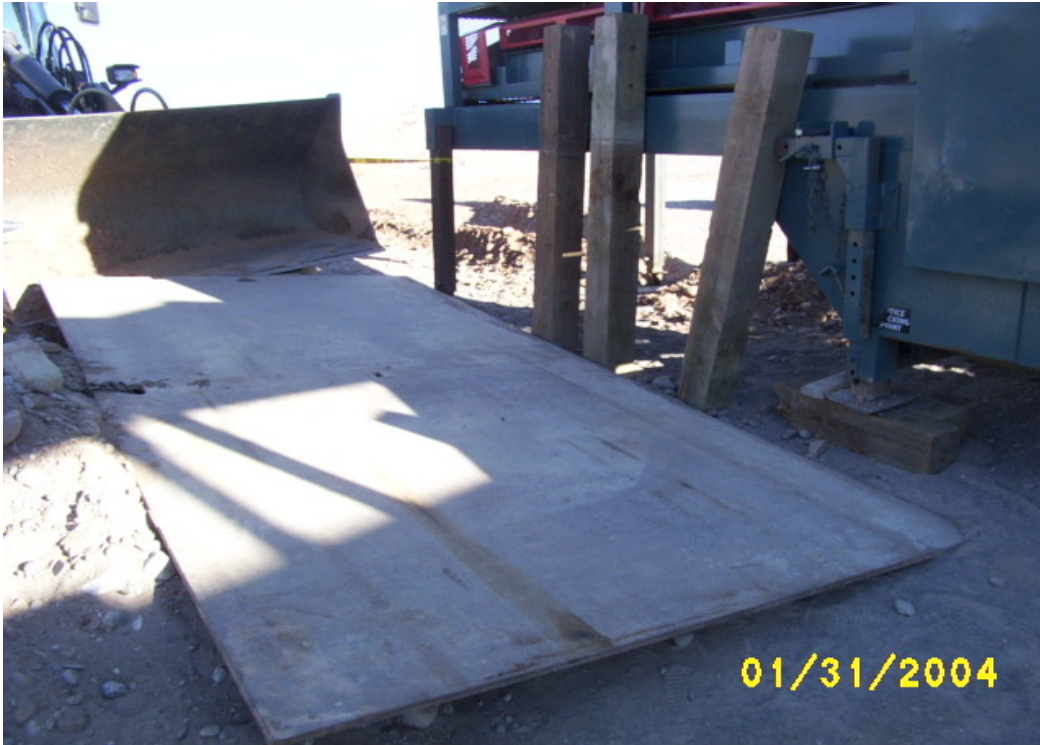
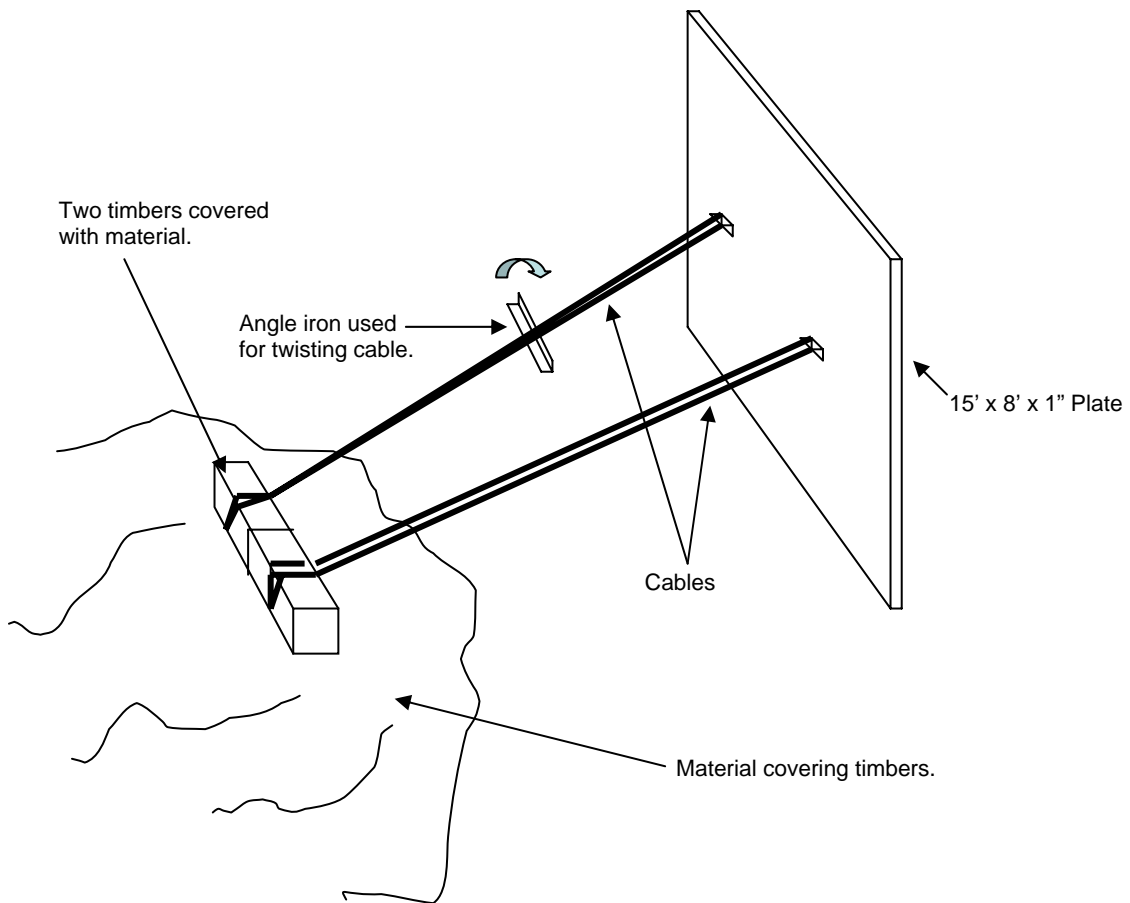
On January 30, 2004, Isaac Tabor, plant manager, age 60, was fatally injured when a steel plate he was erecting as a ramp bulkhead, fell crushing him. Tabor was using a piece of angle iron to tension one of two anchor cables when the plate fell.

The accident occurred because the plate was resting on its edge, leaning against wood timbers and was not blocked or secured to prevent it from falling. The victim positioned himself within the fall zone of the plate while attempting to remove slack from the cables connecting the plate to a buried anchor.

The plate leaned against five timbers (8 inch by 8 inch by 8 feet long) that were placed against the plant feeder hopper. The steel plate was placed in a near vertical position leaning against the timbers. The plate was not secured against movement away from the plant. It was

determined that initially the plate leaned slightly off of vertical toward the power screen (away from victim).

**Causal Factor:** The bulkhead plate was about 5 degrees off vertical resting on its edge against the plant. It was not secured or blocked to prevent it from falling.

**Corrective Action:** Written procedures should be established to identify safe methods for building ramps that include installing the bulkhead plate. Personnel performing this task should discuss the procedures and be familiar with all measures to ensure safety.
